Quick Scan Marine Environment

Ecosystem and Biodiversity Composition and Potential Negative Impacts of the beach development activities in front of the Hilton Embassy Suites, at Eagle Beach.

Authors	Sietske van der Wal, MSc Giancarlo Nunes, MSc Helena Eicher, BSc (MSc intern)	Reviewed / Approved	FPNA Executive Board
Version	3.0	No. of pages	14
Topic	Ecosystem, Biodiversity and Threats Quick Scan	Date	5 July 2023

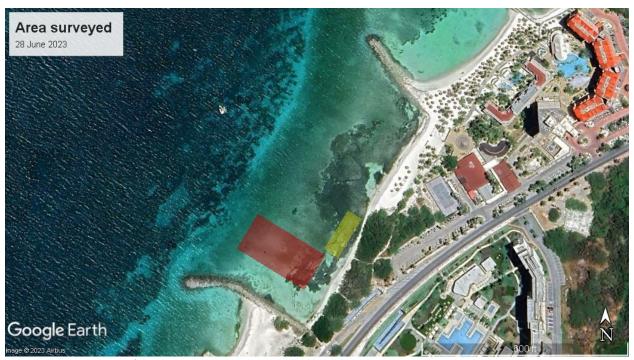
Image 1: Areal overview of the bay with the two areas covered by the roving surveys.

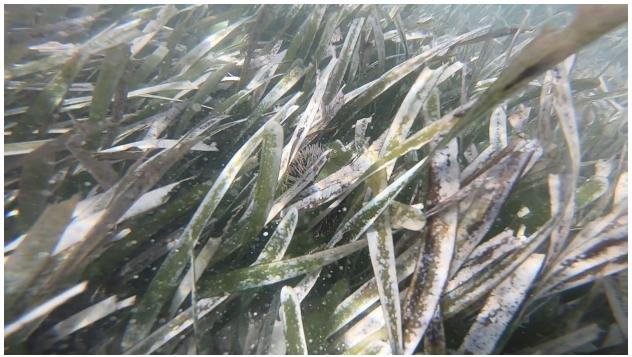
Image 2: Dense seagrass bed of Turtle grass (Thalassia testudinum) is home to many species such as the West Indian sea egg (Tripneustes ventricosus) sea urchin.

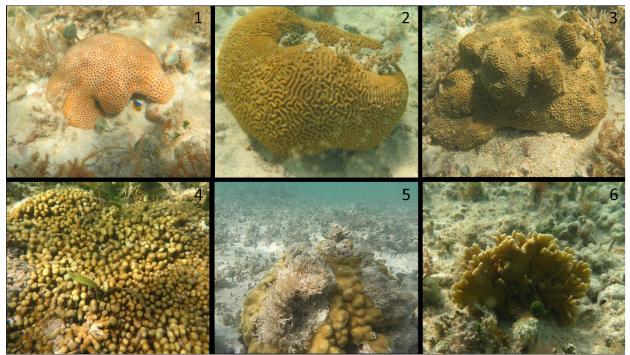
Image 3: The observed corals (1) Shallow water starlet coral (Siderastrea radians), (2) Symmetrical brain coral (Diploria strigosa), (3) Knobby brain coral (Diploria clivosa), (4) Thin finger coral (Porites divaricata), (5) Mustard hill coral (Porites astreoides), and (6) Fire coral (Millepora striata).

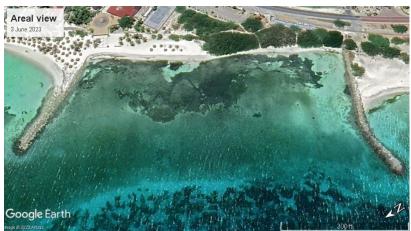
Based on the drone and satellite imagery, a comparison over time (Image 4, 5 & 6) illustrates the formation of new paths through the Buttonwood mangroves (*Conocarpus erectus*), fragmenting this important mangrove forest. Additionally, mangrove die-off can be observed, especially in the section that is now fragmented from the rest and has additional pressures from increased traffic on the new paths.

During the survey, it was also observed that the south-eastern corner of the bay had been filled with a large amount of white sand (Image 5 & 6), covering seagrasses and corals and inhibiting them from the sunlight they need to survive (Image 7 & 8).

Image 5: Areal view of the bay on 3 June 2023, extracted f Google Earth on 29 June

Based on the presented findings FPNA recommends keeping this marine sanctuary as pristine as possible and not developing this into a white beach area for recreation. There are already developed beaches and access points to the sea on both sides of the adjacent dikes that can be used for human recreation and enjoyment. FPNA additionally recommends only allowing walking over this section of the coast as a connecting beach, but not to swim or wade in this area as it is very shallow and highly sensitive to trampling.

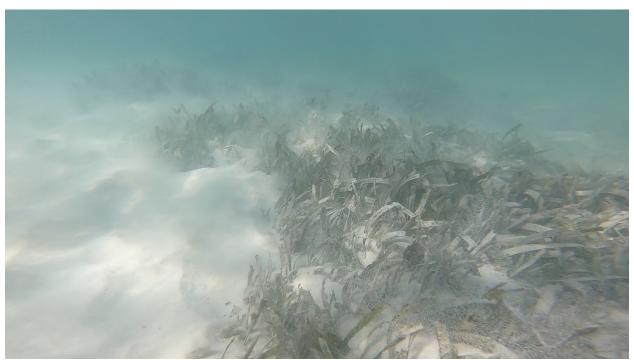
Image 5: Turtle grass (Thalassia testudimun) being covered in sand.

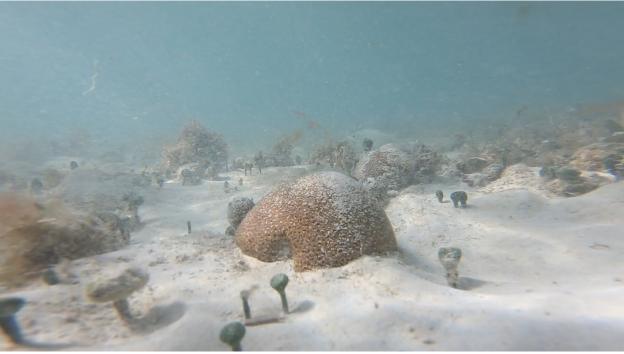
Image 4: Shallow water starlet coral (Siderastrea radians) being covered in sand.
